# West Oaks Dock Section Rebuild and Reinforcements – Winter 2015

# Original Dock Design

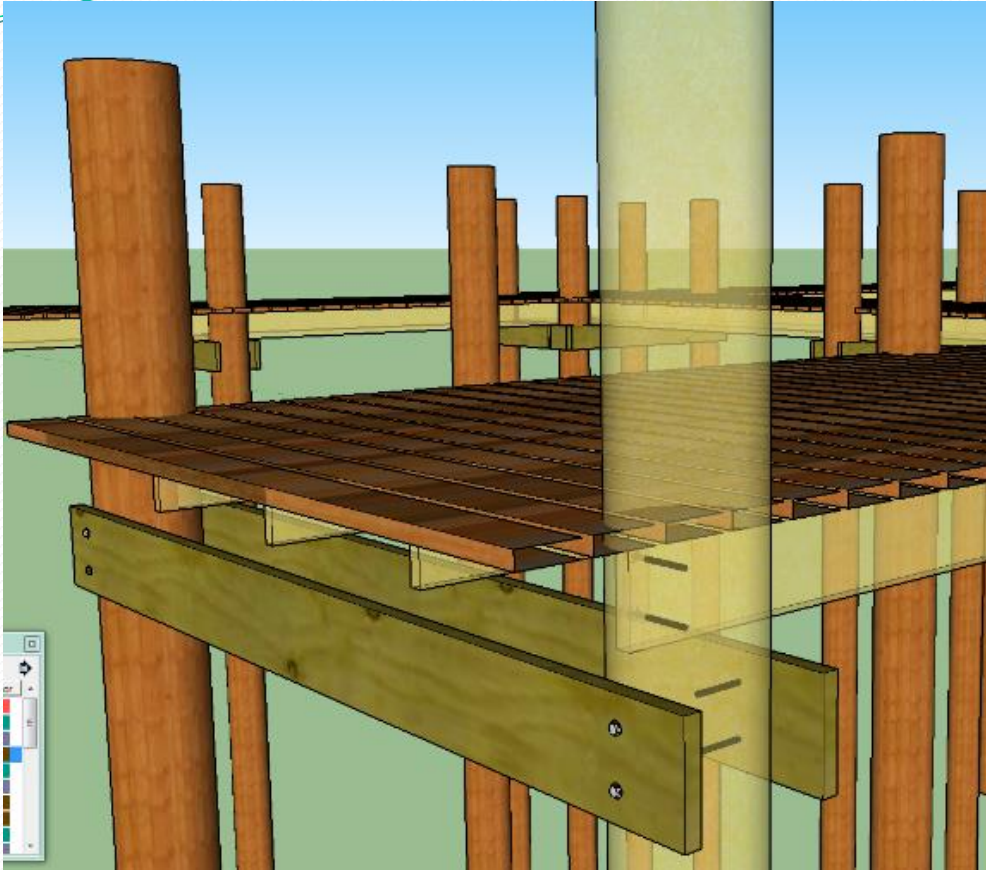
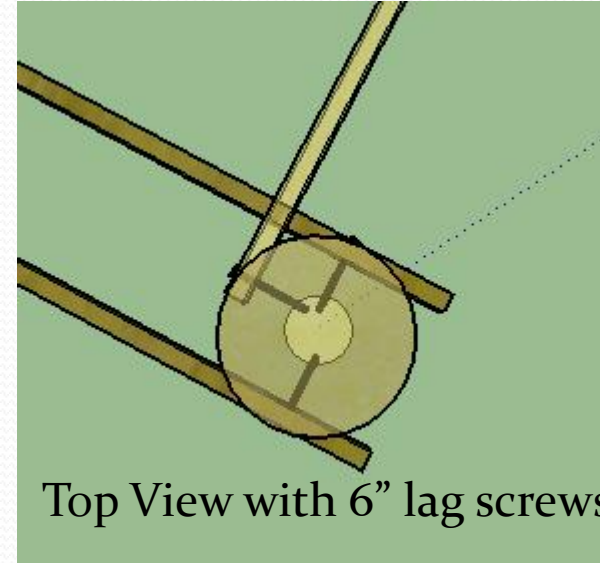
Top View with 6" lag screws

- Originally only 6"x3/8" lag screws attaching 2x10 joists to poles
- – easy to tear out of poles
- Poles not really tied together
