# West Oaks Dock Section Rebuild and Reinforcements – Winter 2015

# Original Dock Design

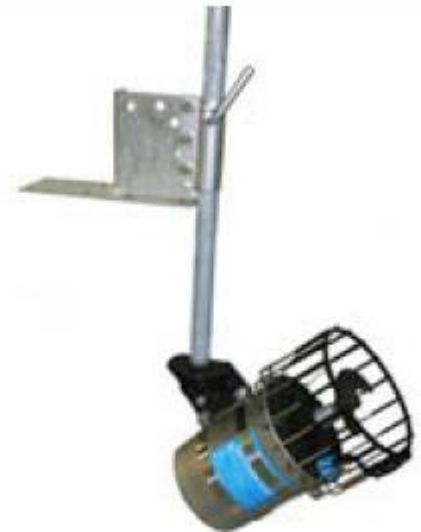
- In addition, the expansion of ice during the winter ratchets the dock towards shore building a cumulative leaning of the docks poles inward.
- De-icers or ice bubblers were purchased and installed to help alleviate this issue by keeping the end of dock ice free.
  - Proper register licensing with DNR, public announcements, and sign requirements were followed to minimize liability concerns.
  - Thin ice signs are monitored on a weekly basis.
  - Signs posted at public boat launch and at dock gate.
  - Lock placed on dock gate to discourage people from accessing dock during winter months.
